PROPERTY INSPECTION REPORT

Date of Inspection: August 22, 2018

By: Fernando Martinez, Professional Inspector #2945, Wendy Matson #3666, Elissa Martinez #10490

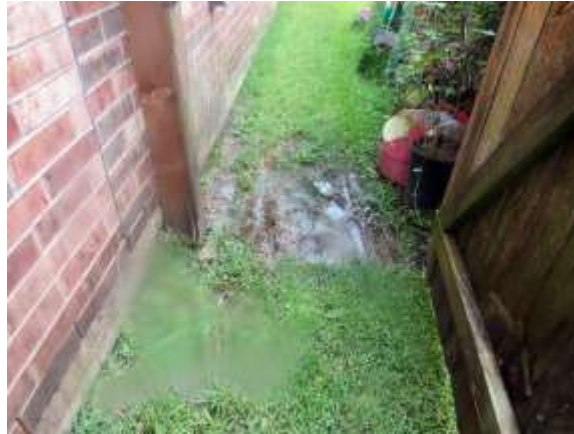
1. At the left side of the house, near the gate, the swale has been filled in and must be re-established - The grade around the home should be such that there is positive drainage away from the foundation wall.

A swale was built into the yard of this home, it can be reestablished by digging the soil out to direct water flow. A swale is needed at this area.

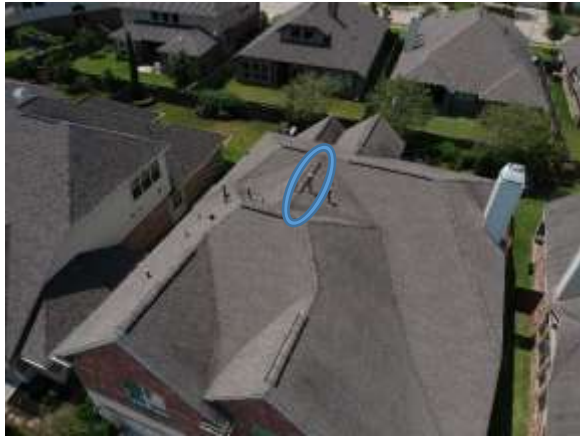
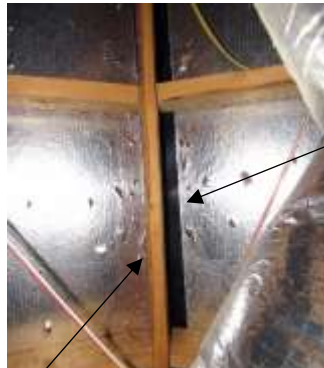
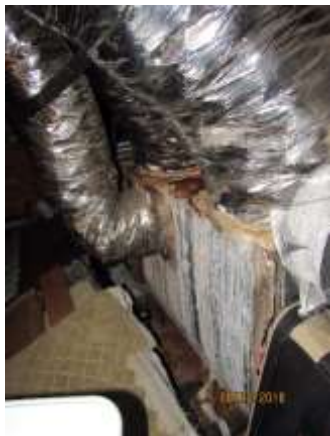
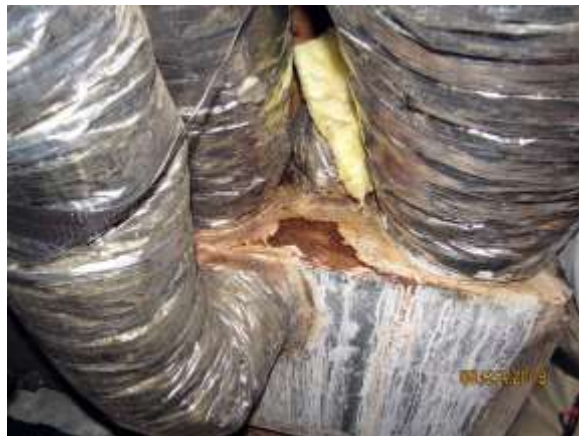
- 2. All ridges have ridge venting, which is needed to allow hot attic air an exit, however, the ridge over the a/c units, area circled below, the shingle sheathing has been cut excessively, which allows rain into the area and onto the a/c units, which has severely deteriorated the metal fixtures. An a/c technician is needed to determine whether this has created holes or other problems on the interior of the units. Repair needed to this ridge by removing the existing vent, adding wood to one side of the ridge and remove 1” of wood from the other side, then reinstall vent.

Cut too wide

Not cut enough

Above photos and photo below show damage done to a/c units from incoming water

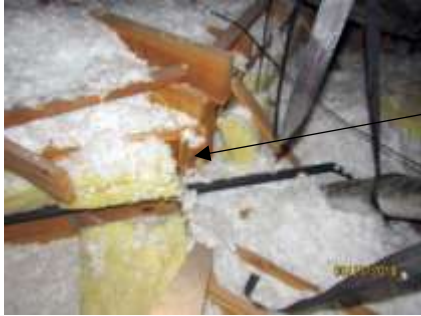
1. Location of attic space: upstairs hallway
2. Some vertical insulation is falling off – replacement needed

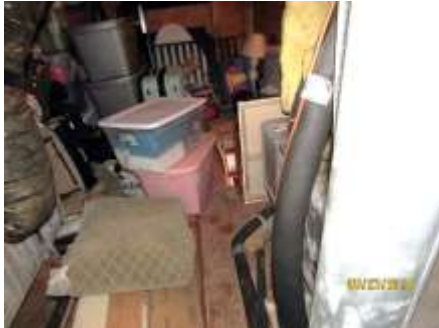
3. Framing: 2" x 8" ridge with 2" x 6" rafters, spaced 24" on center (note)
4. Difficult to maneuver in this attic (note). Walkway crowded with belongings.

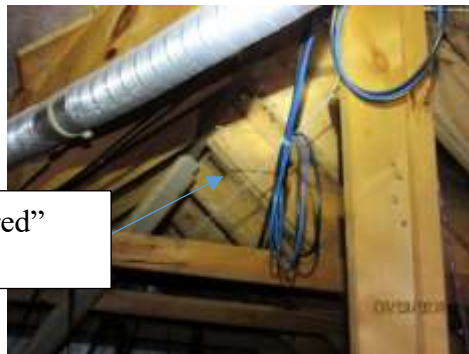
5. The front garage area was observed to have several rafters that had been "sistered", meaning repair by reinforcing by adding additional rafters to existing ones. They had not separated from the ridge (note). This would be the proper repair for separated rafters.

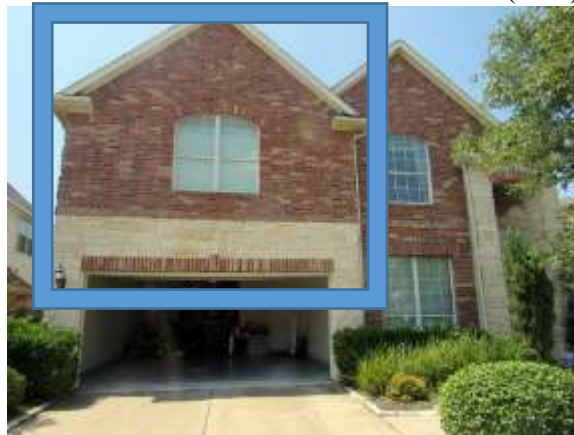
- 1. The cladding of this home is brick with natural stone (note)

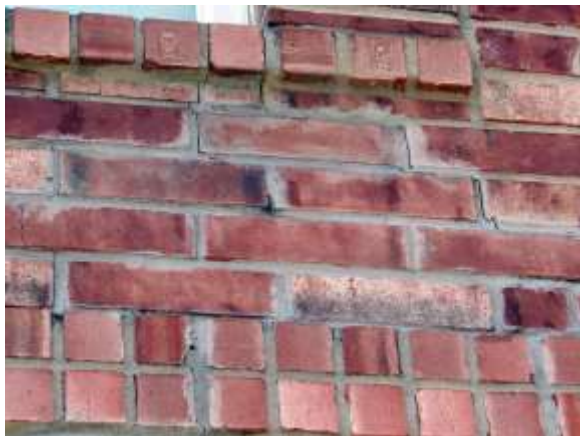
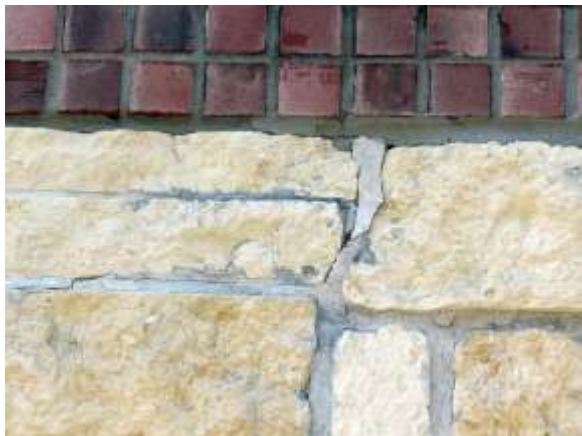
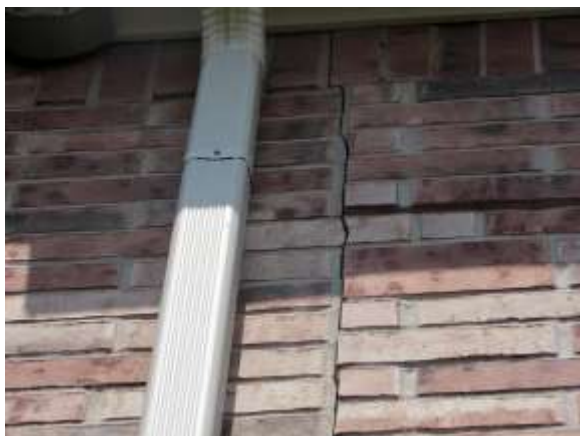
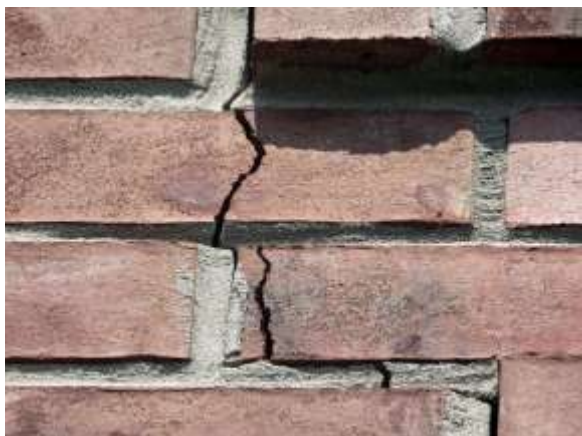
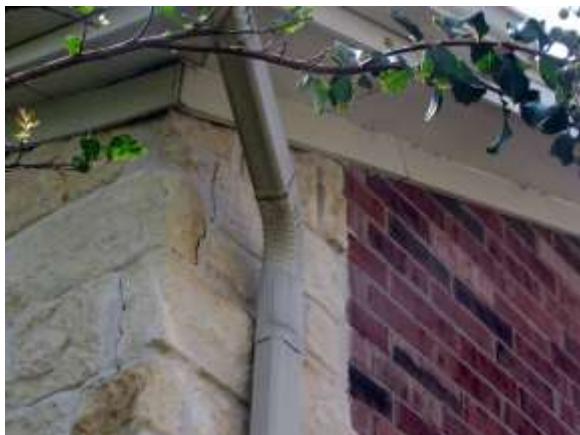
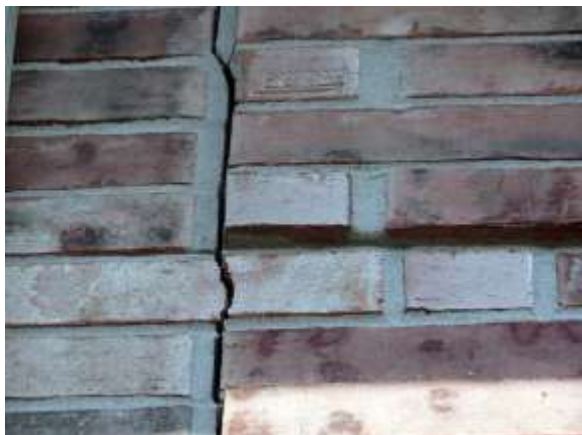
- a. The front of the home, where the overhead garage door opening is located shows multiple cracks, both at the corners and in the center (which is also deflected), which indicates excessive stress. The left and right sides also show stress and movement as separation that is cracking the bricks.

All photos on this page show cracks in and around the front overhead garage door area

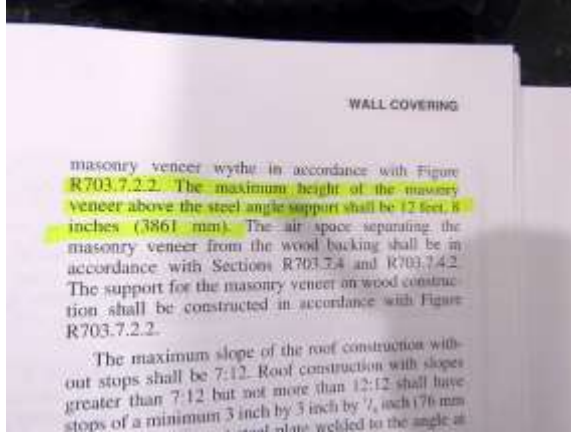
- b. The maximum distance above a lintel is only 12', as shown in the code manual, below. This area has 18' above it. Measurements were taken on the left and right sides of the lintel (right side was 1" higher than the center within 8' and then 1/2" higher on the left side = deflection of 1")

- i. The repair would be to remove all brick at this area in order to install a double lintel.
 - ii. Note that the lintel itself was installed properly (it is the excessive weight above it that is causing the problems)
2. Left elevation cement board siding has come apart at the joints. Re-nailing and caulk needed.

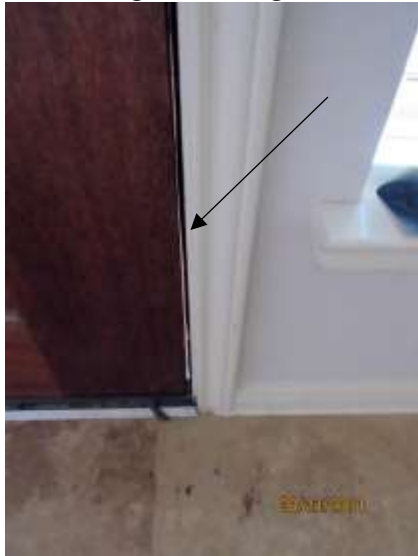
- 1. Front door has light showing at the bottom opening edge – more insulation needed.

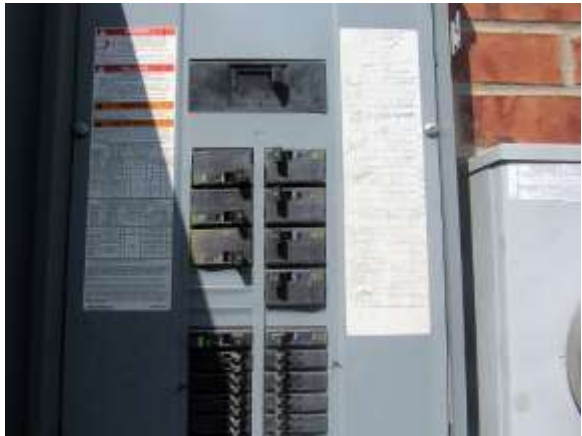
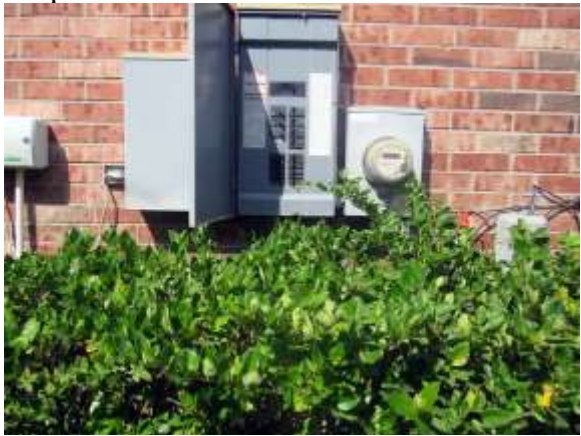
1. The following information, unless otherwise written “deficiency” is considered a note for reference purposes:
 - a. The panel box was located on an outside without 3’ clearance required by the code from the bushes that did not allow the inspector to access the interior of the panel in a safe manor. The bushes **MUST** be cut back. (deficiency)

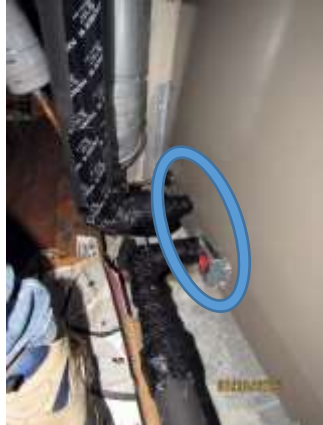
2. A/C units:
 - a. Unit #1 on the left of attic:
 - i. Condensation drips into the pan due to lack of enough neoprene insulation and/or proper sealing around the protrusions, shown below. Need to use UL silver tape covered with high velocity duct sealant.

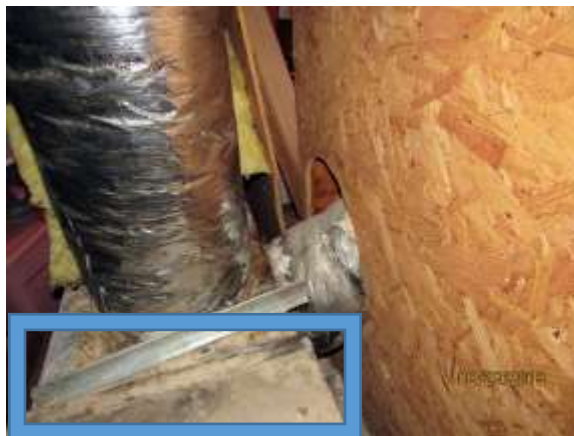
1. The condensation has caused mold growth on the surface of the unit.

Note that mold growth on the surface of unit indicates the attic is too humid. This can be eradicated by using a solution of 10 to 1 solution of water to bleach, sprayed on by a person wearing gloves and an N-95 mask.

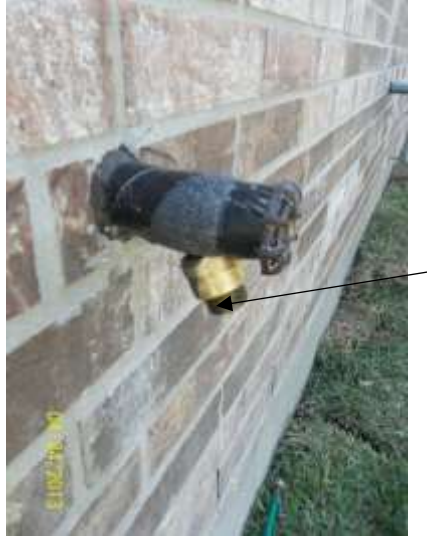
- 2. Exterior faucets did not have anti-siphon devices on the end, which are shown in the photo below:

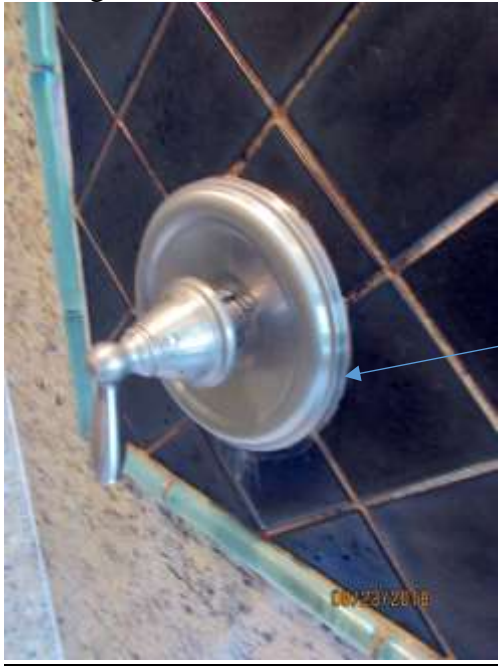
- 3. Interior problems found:
 - a. Caulking needed around escutcheon plates. The master shower escutcheon plate has staining around the bottom that allows inspector to think water gets inside on a regular basis.

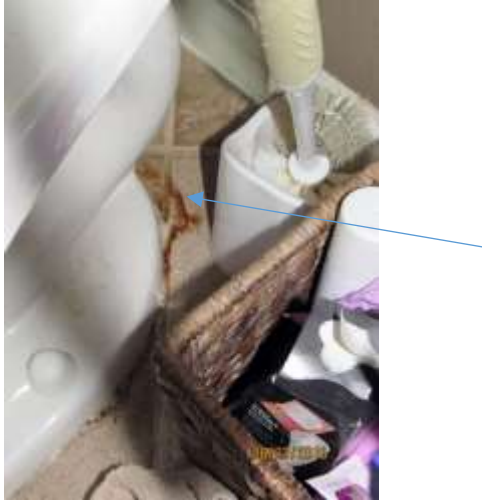
- b. Master toilet shows signs of water leakage – reset with new wax ring

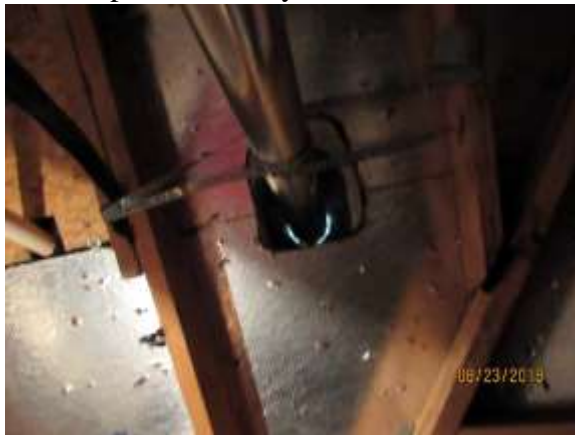
1. First unit flue has light showing around it, likely indicating rainwater penetrates into the attic. Repair needed by roofer.

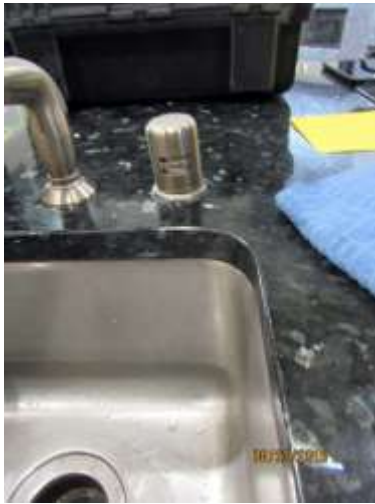
1. The dishwasher is not fastened to the cabinetry
2. The anti-siphon device on the countertop is leaking during discharge cycle – cleaning of hoses needed.

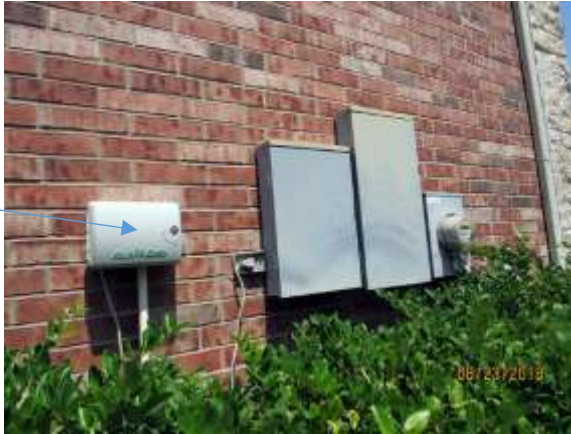
- 1. The panel is located on the left elevation exterior wall. It was not accessible due to bushes

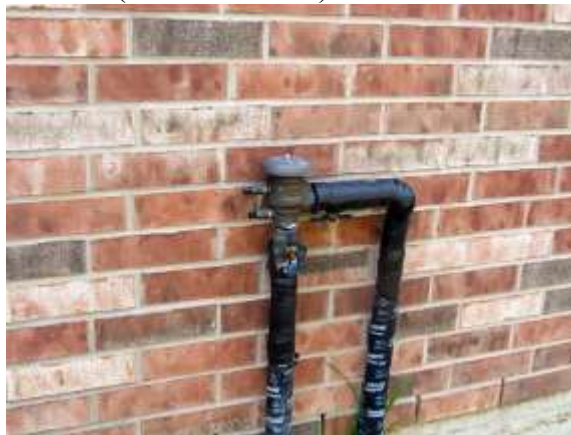
2. The sprinkler back flow preventer is shown below.
 - a. The handles are/ rusty – they should be changed or sprayed with an anti-rust solution (We use “Gem”)
