INVASIVE STUCCO INSPECTION

Date: February 22, 2018 **Date of Inspection:** February 22, 2018

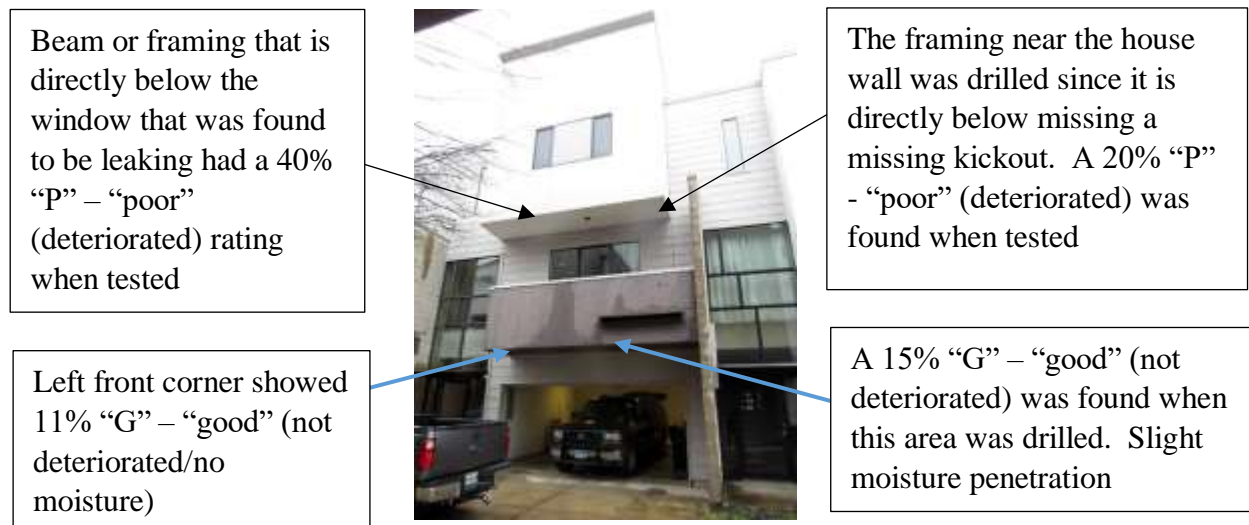
1. Framing that supports the cantilever and the balcony are drilled to determine the condition of the wood within. The following was found:

Summary: The cantilever for the third-floor front windows is deteriorated and very wet, due to both window leaking and also missing kickout on right (left side kickout could not be tested but is also missing.)

The lower balcony was found to be in good condition – no deterioration at either area drilled, however, slight water penetration on the right side under the scupper was found.

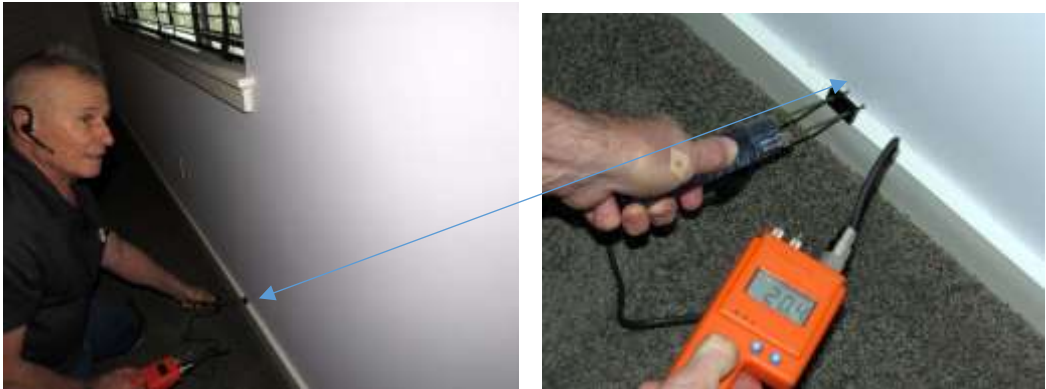
Location	Floor	Left	Center	Right
Front window (looking at the house from the street)	3	20.4%P	-	13%G

Summary: The window has allowed enough moisture into the structure that it has deteriorated the wall sheathing below (the wood that holds the stucco) and also down into the cantilevered area, which is deteriorated (See 3. #1)

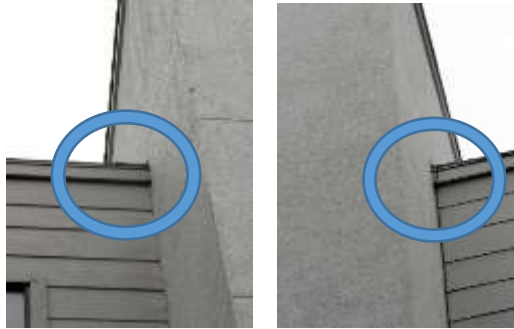
2. Kickout flashings* – wherever roofs meet stucco sidewalls, such as at both sides of the cantilevered window area, kickout flashing **MUST** be present. The right side of the cantilever was drilled, which was found to be wet and deteriorated (see 1. #3)

Locations where kickout flashing is required

We recommend that Wind-Lock brand be used, shown at the end of this report. Stucco work should include “following the water trail” to assure that all deterioration is found, and source identified. Replacement of wall sheathing must be with plywood (not treated).

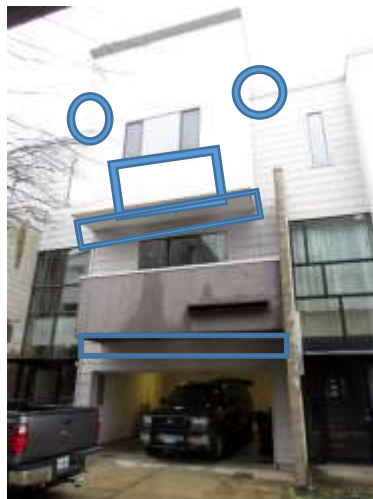
Areas outlined in blue show where stucco removal is needed

1. Removal of the front cantilevered wall underneath in order to repair/replace any deteriorated structure within and removal up to bottom of window in order to positively identify water penetration point and also replace rotted wall sheathing - continue to follow water trail until the source is identified.
2. Removal of stucco from around cantilevered wall where the roof lines meet on both left and right sides. Install Wind-Lock kickout flashings, see end of report. Replace any deteriorated wall sheathing with plywood

1. Removal of existing caulk from around metal cap/coping and from around scupper in order to use NP1 urethane
2. Remove stucco from underneath area of balcony in order to identify and repair any water penetrations, particularly around the scupper. Install 75 FPM moisture screed underneath the edge. Remove rocks from edge to allow viewing of perimeter.
