# Preferred Home Inspections, Inc.

## MOISTURE AND STUCCO REPORT

Date: February 13, 2012

Concerning: *6455 Bell Drive, Dallas, Texas*

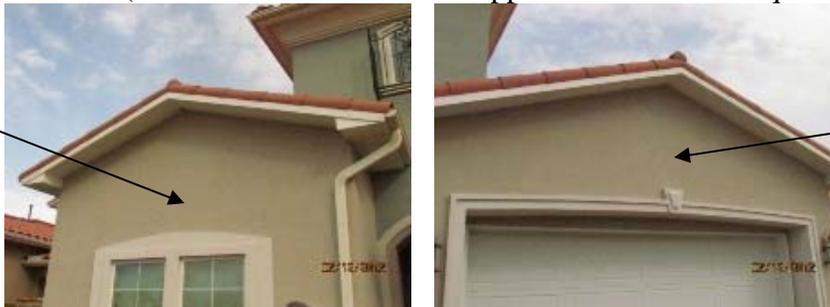
Surface cracks were seen on all surfaces, except the raised area and lower area of EIFS. Conventional stucco must have control joints every 144 sq. ft. for expansion and contraction relief. There were no control joints at the front elevation, left and right areas. The rear elevation stucco had control joints (at exactly 144 sq. ft.) as did the left and right sides, however, cracking was still evident. (Note that EIFS area of the upper front does not require control joint.)

Above photos show where control joints are needed

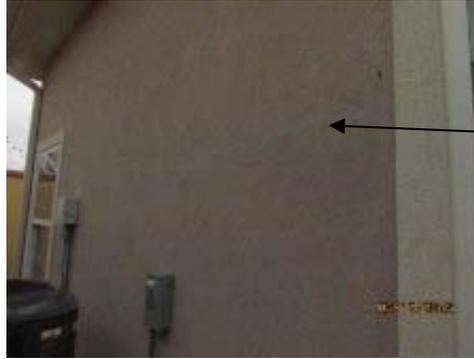
At the rear elevation stucco crack area, inspector pressed on the stucco to show that there is “give”, indicating a likelihood of not enough nailing and stapling or gap between the OSB sheets.

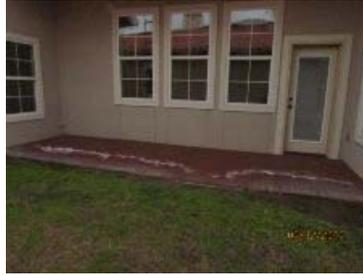
Left elevation porch

**D. Visibility of foundation, porches and roof surfaces** This type of stucco should and does have a “weep screed” on the lower edge of the stucco to complete the “water drainage system”. There was good slab visibility and drainage at the front and right elevation grading but not at the left elevation and rear elevation, where 2” or less was found at the grade. Areas of porches did not have good visibility - 2” of visibility at paved areas of 4” at grade are required.

The finished edge of the stucco wall should be located not less than 4 inches (102 mm) above raw earth or 2 inches (51 mm) above paved surfaces.

Due to the high grade between the home on the left side and high grade at the foundation of this home, wicking of moisture into the substrate and rusting of the weepscreed is inevitable. To obtain more distance between the stucco and grade, the inspector recommends regrading the existing area by removing 6" of soil, then reinstall sod. Regrading so that rainwater flows to the street is needed. \*IRC code ref Grading

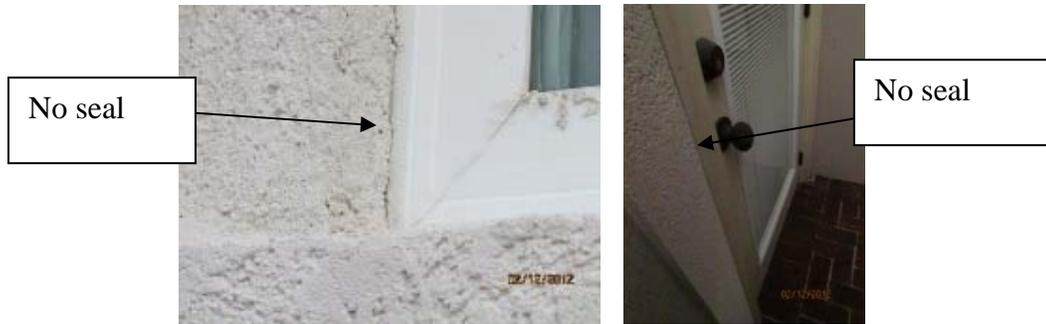
A quality seal between the dissimilar materials of metal window edges and wood door casings is required where polystyrene is installed. This seal consists of a 1/2" gap at the edge, into which a closed cell backer rod is inserted, and then the joint covered with a good low modulus caulking, such as NP1. The entire system, as described above prevents water penetration from occurring between the window frames and door casings. There wasn't a proper seal, as described, on the dissimilar materials of this home.

Next best seal is a well-kept properly applied caulk seal using good caulk, such as NP1. The existing caulk on the dissimilar materials of this home was in poor condition where found and some areas were not caulked.

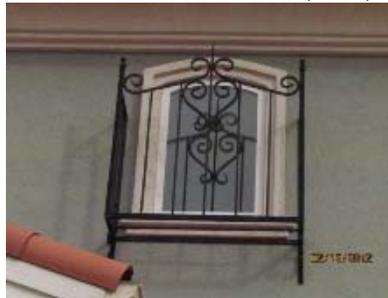
A window with Juliette style railings has been installed on the upper level, front elevation, which had no access from the attic (note).

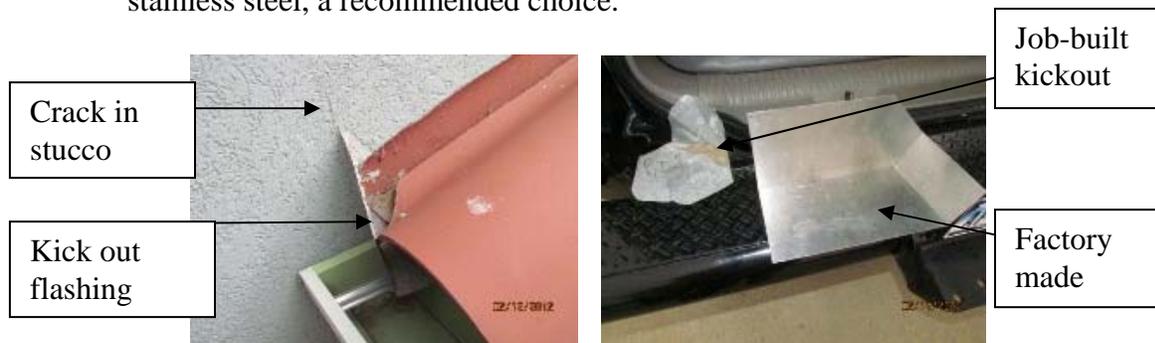
The front entry roof lines had specialized flashings installed, called “kickout” flashing. However, on the front elevation, right roofline, the kickout was insufficient or improperly installed and the gutter below was butted up against the stucco therefore water penetration could be due to either protrusion.

Above photo, left, shows existing flashing; above photo, right shows examples of job-built flashing such as found on this home compared with factory built flashing

In the photos below, the photo on the left shows a builder grade kickout, which is job built, bent and caulked at the joint, like the one on this house. The kickout on the right is a quality kickout, manufactured to be seamless and composed of stainless steel, a recommended choice.

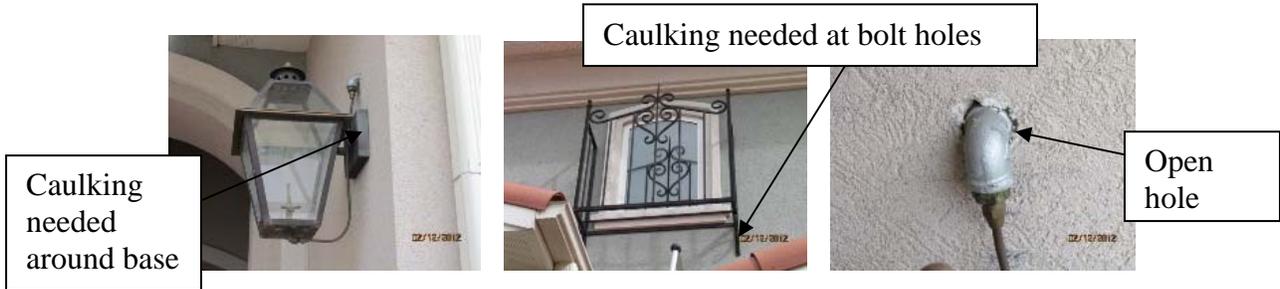
There were many wall protrusions seen on the exterior of the house and none had caulking. It is very likely that all are allowing moisture penetration into the structure. Photos below show examples of protrusions:

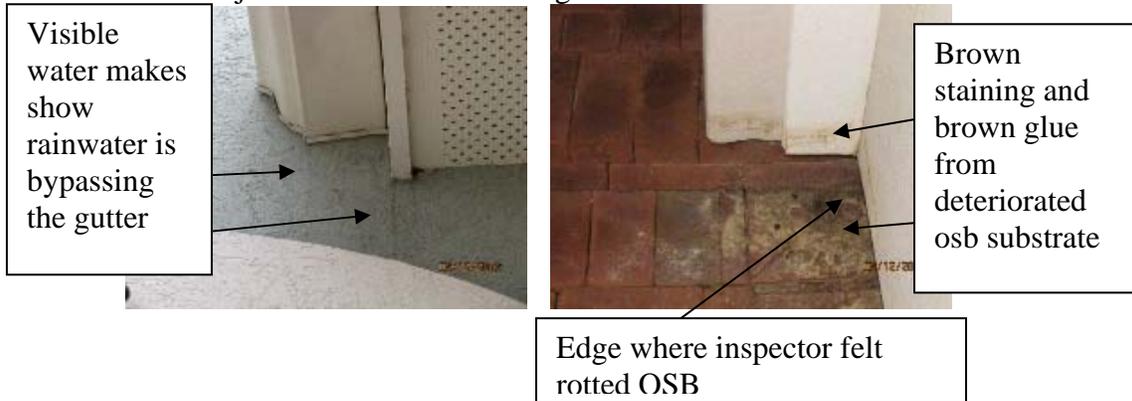
A. At the front elevation entryway, right side, glue from water penetration to the oriented strandboard was seen piled up underneath the edge of the entry in addition to lower wall staining. The inspector was able to reach up and into the area to feel for substrate and found deteriorated OSB, which came out brown and flaky, indicating wood rot. This moisture penetration was likely due to job-made kickout flashing.

- 1. Removal of the front wall, from bottom upwards kickout flashing, continuing until no rot is found on the right elevation and “exploratory” on the left side where second kickout is located. This would be cutting open an area approximately 1’x1’ at and below the kickout. Replace kickouts with manufactured type.
- 2. Removal of all window and door banding so that it can be re-installed with the “proper” 1/2” gap/closed cell backer rod
- 3. Regrading of land at rear and left elevation
- 4. Removal of stucco and substrate and repair of rotted studs at all windows, 1” along left and rear elevation
- 5. Using fiberglass mesh to cover and refinish cracks
- 6. Caulking around all protrusions with NP1; remove bolts from Juliette balcony, insert caulking, reinstall bolts.

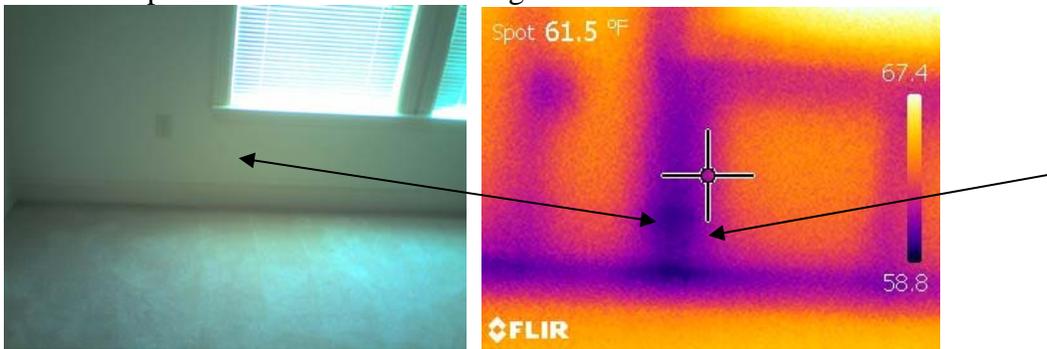
1. Front elevation, left bedroom, window facing street, left side had water penetration on the left and right corners:

Left of window in front elevation bedroom shows moisture at lower left area of window where dark blue shows moisture spreading out from stud

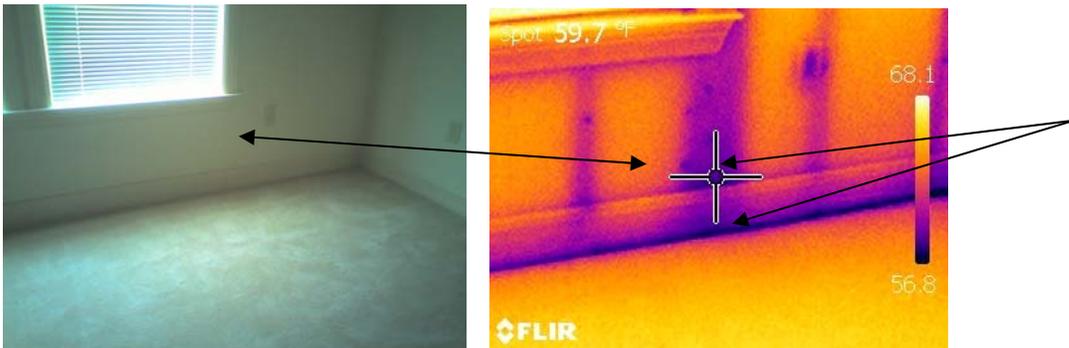
Right of window in front elevation bedroom shows moisture at lower right area

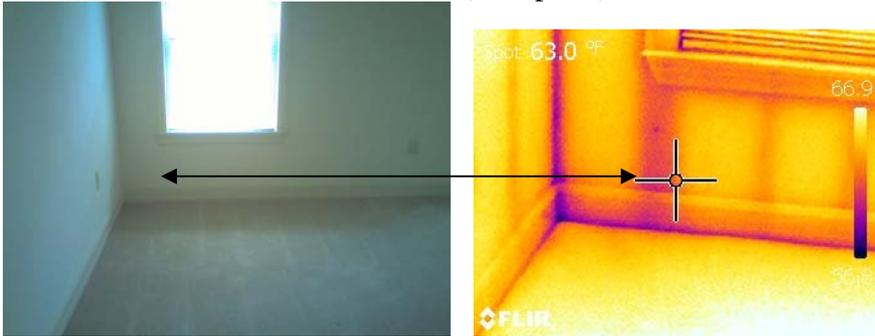
2. Left elevation bedroom (near patio)

Left side of left window shows moisture penetration

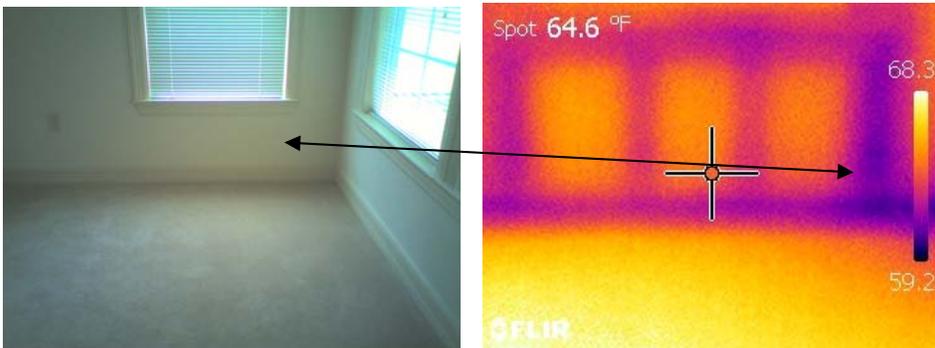
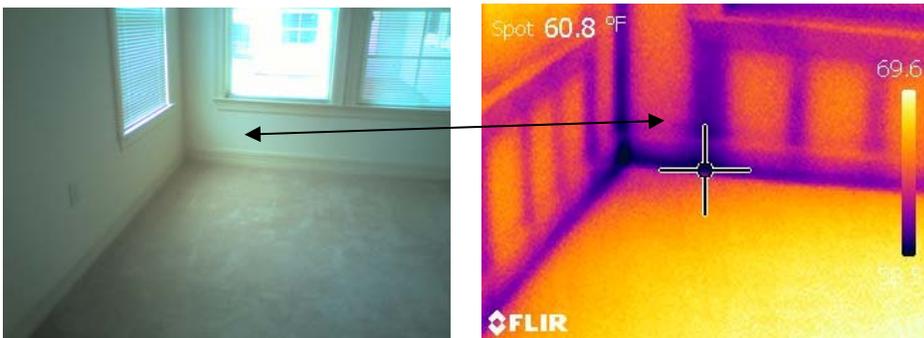
3. Left elevation bedroom, window facing left elevation:

Above photo depicts left and rear facing window of second bedroom showing moisture penetration coming in on right side of left window and left side of rear facing window.

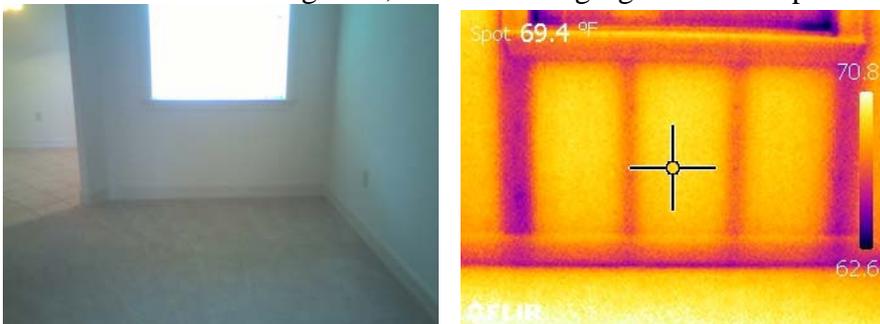
4. In the diningroom, window facing right elevation patio showed moisture

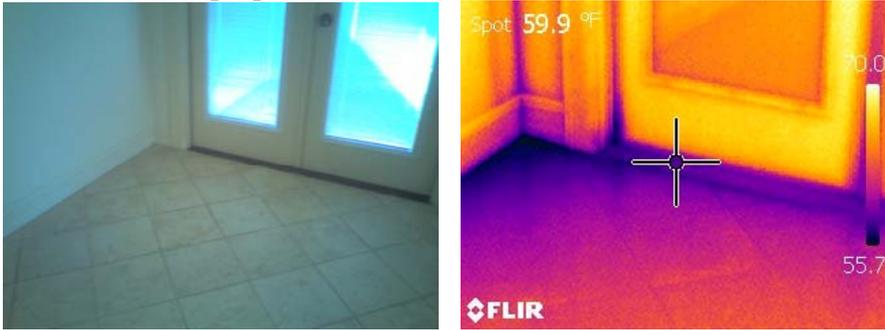
5. Door facing patio on right elevation only appears to show cold air as dark blue/purple

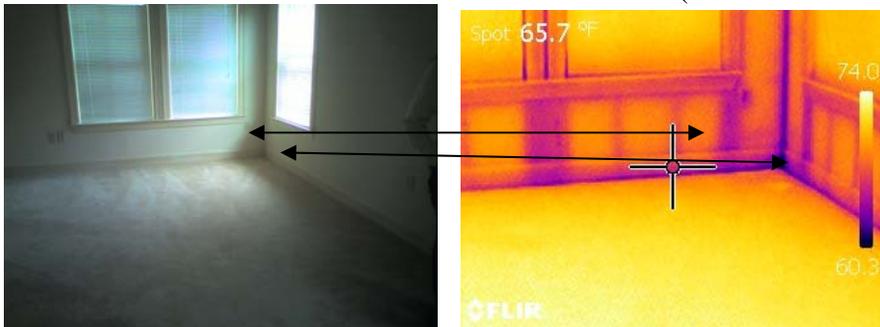
6. Left elevation master bedroom windows (no windows facing rear)

Above photo shows windows on left facing patio and window on right facing left elevation (note that entire window would not fit into same image)
