PREFERRED HOME INSPECTIONS, INC.
Licensed Mold Assessment Company
Mold Assessment Report
713-249-8581

Date: March 7, 2018 **Date of Inspection:** March 3, 2018
Prepared for: [REDACTED]
Concerning: [REDACTED]
Contact: [REDACTED]

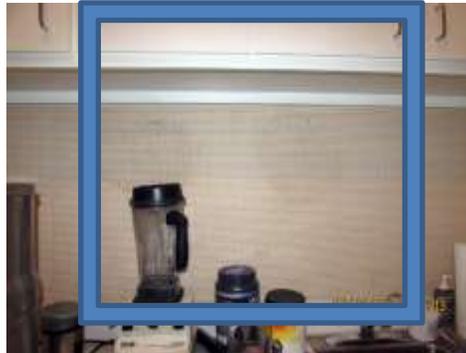
1. Laundry room - Visible mold growth was seen in the exterior wall of the laundry room and on the art, that had been hanging in the vicinity. Inside the cabinetry above, the wall was found to be wet at .7%, scale 3, gypsum, but no higher. The moisture was also not found at either end of the wall but as centrally located.

Moisture found using the Tramex Moisture Encounter and the Delmhorst BD2100 showed that moisture was centrally located and not on the far right or left

The wallpaper on the walls were vinyl type, which can retain moisture and allow mold growth. Due to chronic water penetration, heavy mold growth is expected inside this wall and under the paper. Recommend removal under proper containments and EPA guidelines. Moisture testing showed that the moisture started within the lower cabinets at .7% - .8%, scale 3, gypsum and running downward. The moisture was not found on the right or left sides of the central area, leading the inspector to suspect the cause may be plumbing within the wall for the laundry sink or drainage from the water heater found to be leaking in the attic whose pipe runs down the corner of the same wall.

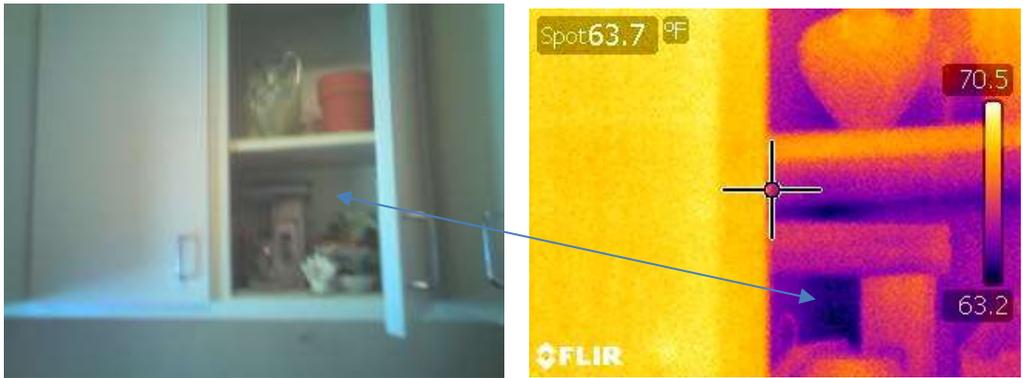
The digital image of the area discussed, above left, and duplicate infra-red image, above right, shows a “moisture signature” as blue (cooler) against a background of yellow/orange, which is warm

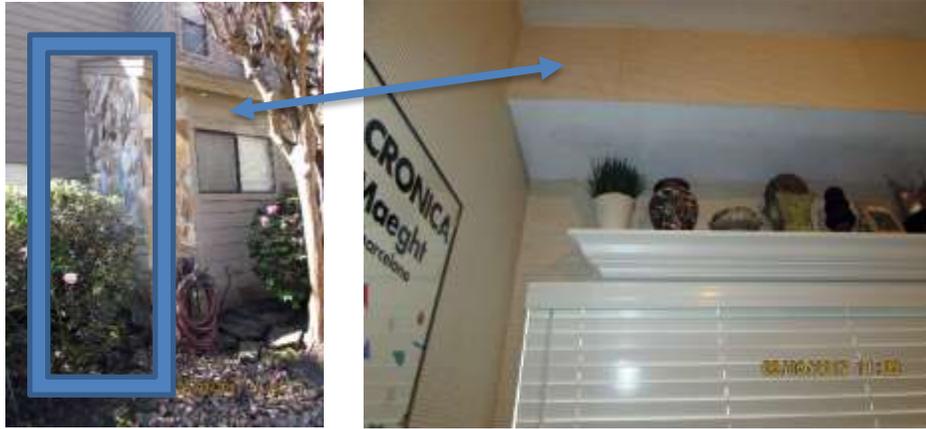
Water stains on the ceiling in the laundry room ceiling, both on the furdawn above the window and the actual ceiling proved to be dry when tested, leading the inspector to believe that this incoming moisture was during heavy wind/rain events that was severe enough to stain the ceiling, but not chronically.

Above photo, left, shows area outside of the wet front wall of the laundry room being discussed. Right photo shows furdawn and ceiling above window that has water stains but is dry.

The walls of the laundry room must be opened to remediate interior mold growth – now positive identification of the cause can be determined.

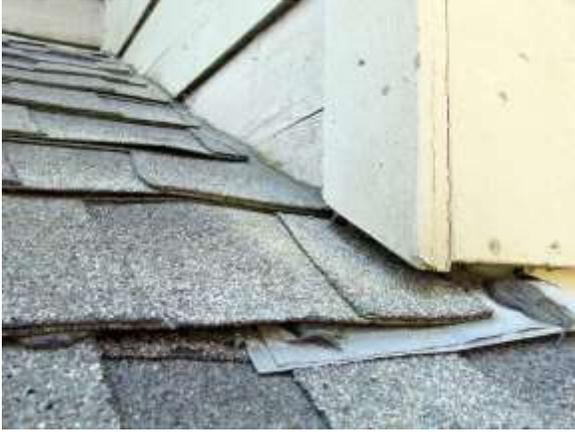
2. Breakfast room wall at windows and secretary desk - at the right elevation second roofline, “J” flashing is seen, not step flashing. The roofline is caulked. The infra-red image below depicts moisture incoming at the lower furdawn area, which runs down the wall and has manifested on both the exterior wall and the lower left side of the build-in secretary desk, which were both wet when tested using the Delmhorst BD2100.

Flashing at this roofline may be the culprit for water penetration into the breakfast room walls, shown below.

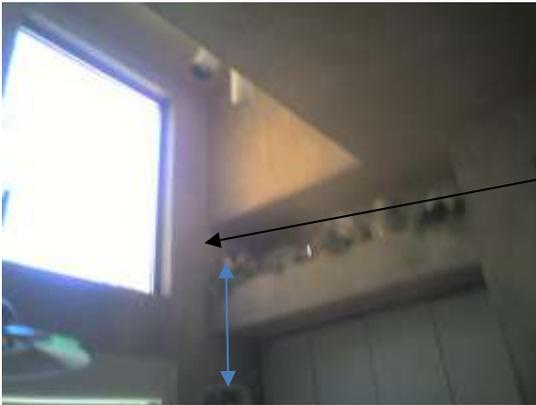
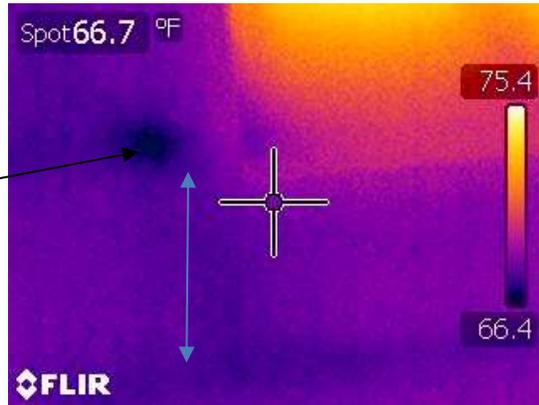
The digital image of the area discussed, above left, and duplicate infra-red image, above right, shows a “moisture signature” as blue (cooler) against a background of yellow/orange, which is warm

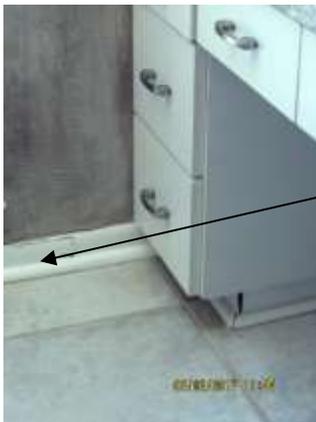
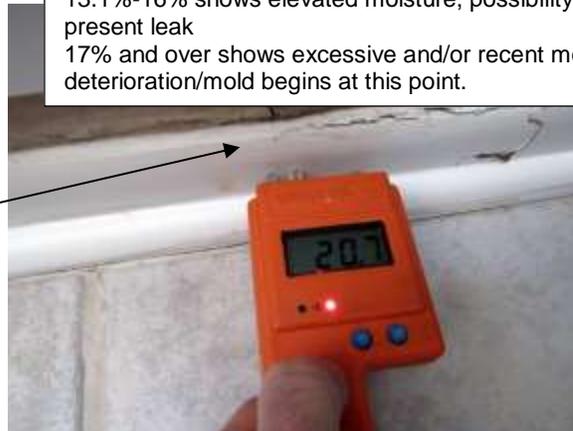
Testing on the baseboard showed a 20.7%, scale 1, wood.

The cabinet and walls must be opened under containment to remediate the mold within.

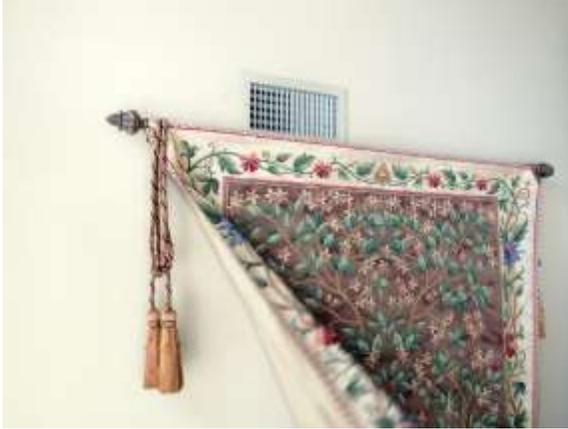
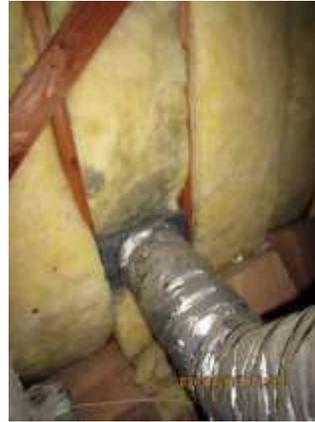
3. Water stains running down the stairwell wall are due to uninsulated register boot seen in the adjoining attic. Recommend insulating the boot to stop the excessive condensation. The insulation surrounding the boot has visible mold growth indicating chronic moisture.

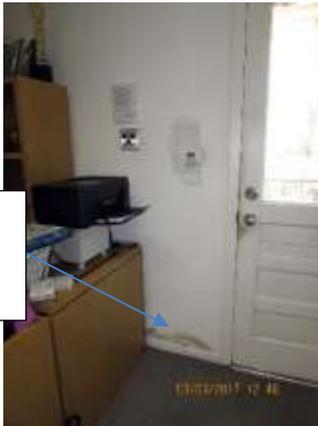
4. The office above the garage had visible water stains around the wall plates below the roofline shows below (dry) and mold growth stains on the lower wall above the baseboard, not presently wet. This is due to the porch roofline/soffit on the outside, which also has deteriorated siding and possibly oxidized flashings.

Visible
mold
growth

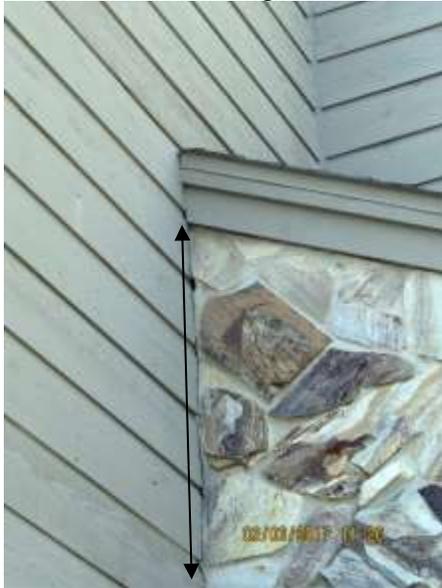
5. NP1 urethane caulking needed between dissimilar materials of stone and wood; also, covering nail heads on the roof

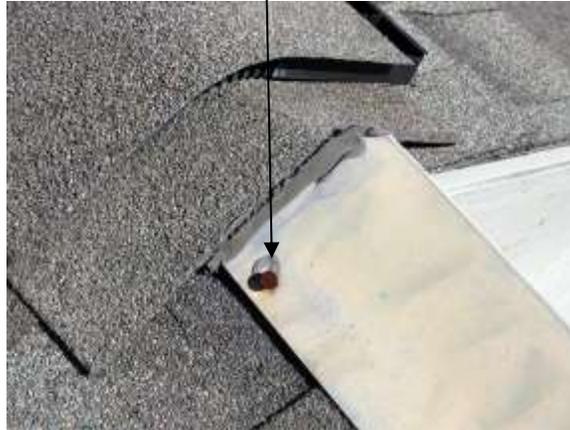
Uncaulked or rusting nail heads allow water penetration into the structure

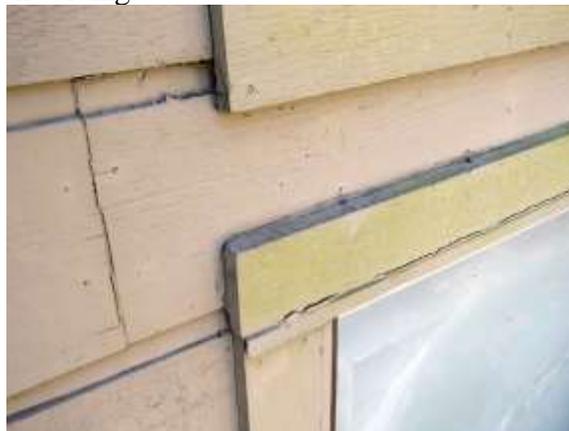
6. Windows on the home were not flashed behind the siding, only the 1" x 4" trim, which can allow water penetration. Removal of 1" x 4" trim needed to install "z" flashing under the siding.

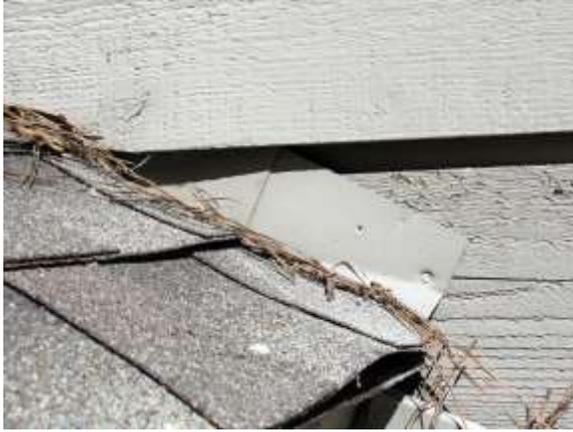
7. The roof on the upper right elevation – siding on sidewall must be removed so that step flashing can be installed from top of the right to bottom. Presently there is only caulk.

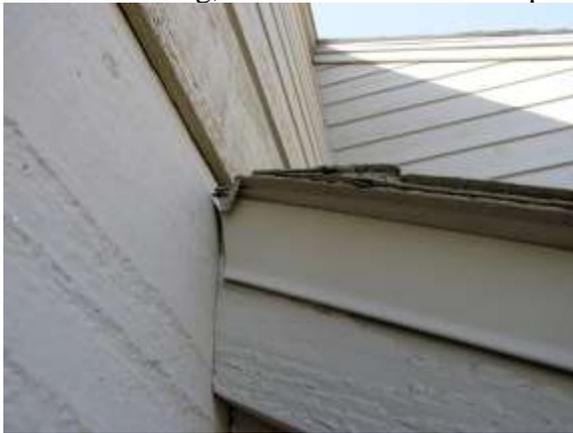
8. The roof on the lower right elevation – same as above
9. The roof at the front entrance – step flashing is not under the siding and has no counter-flashing, which will allow water penetration.

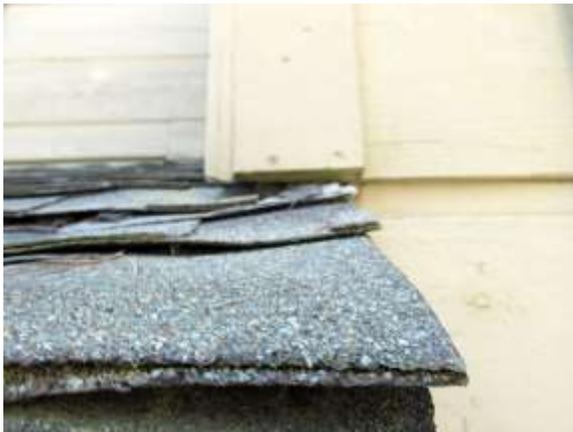
10. Flashing that is popped up should be re-nailed and nail heads caulked with NP2 urethane

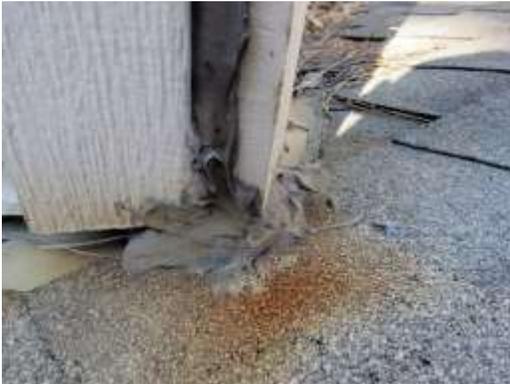
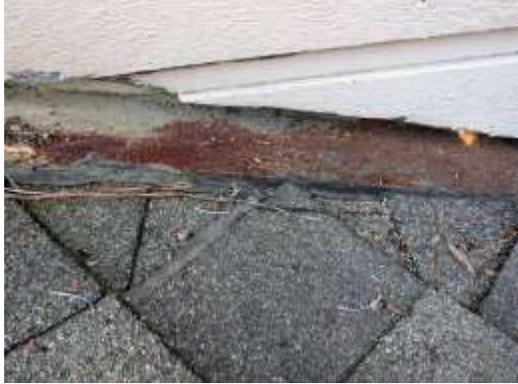
11. The chimney flashing is rusted and should be replaced (where the corner meets the roofline, it is extremely rusted and likely not properly flashed. This will require approximately 1 square of roofing to be removed and some siding.

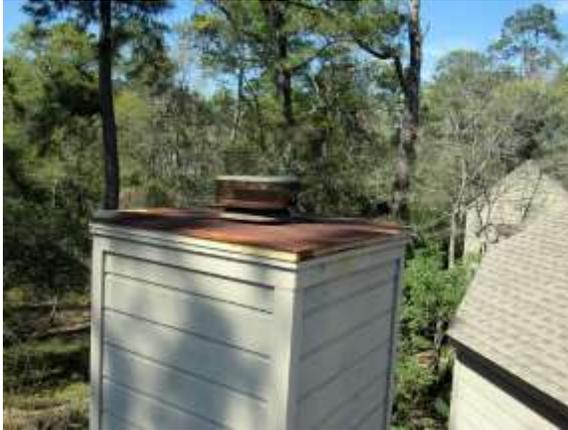
- a. The chimney cap, which is metal, should have an anti-oxidant applied (We use “Gem”).

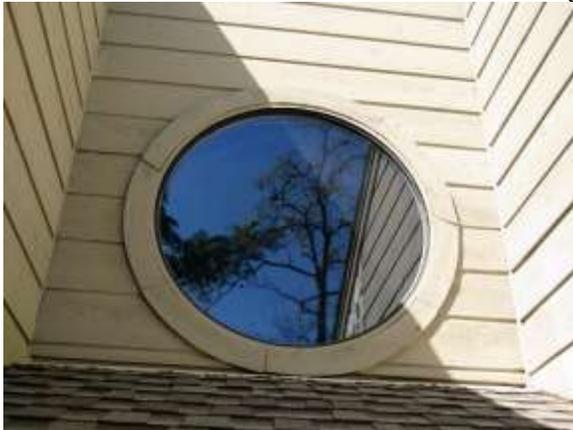
12. Oval window at front does not have caulking between the frame and cedar trim

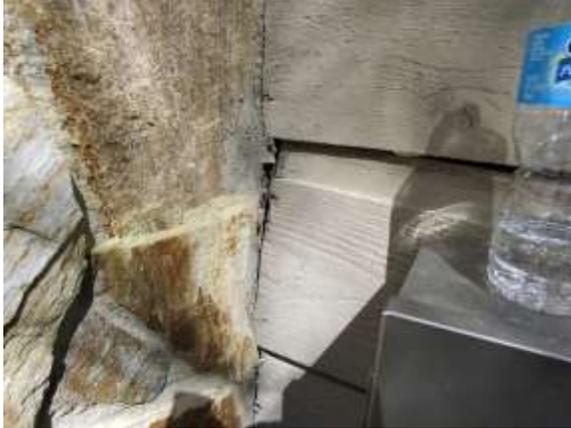
13. Cladding is 12” “lap and gap” cedar. At the front elevation “wing wall” at the left side. No moisture barrier was seen and no caulking between dissimilar materials (stone and siding)

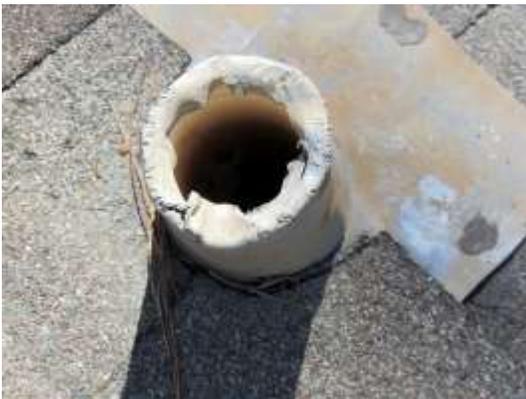
14. The boot covers are chewed by squirrels and should be caulked or replaced with “bonnets”

Existing lead boots with chewed tops

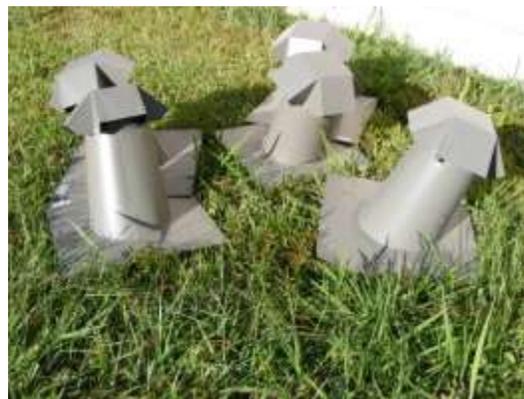
metal bonnets

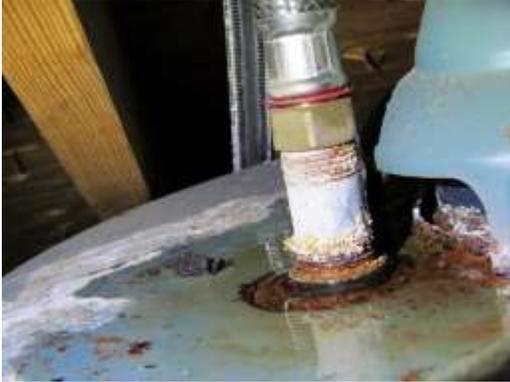
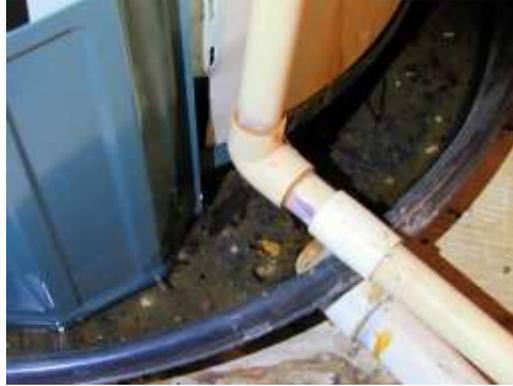
15. On the left elevation, a roofline has a metal “cap” that is rusting and in need of replacement above the attic space is allowing water penetration into the shingle decking and onto the HVAC unit. Roofer needed.
16. On the right elevation attic, oxidized water heater lines are ready to burst – recommended immediate action by a plumber was noted by the homeowner. Note that this MAY be the cause for water penetration to the lower laundry room wall.
