PROPERTY INSPECTION REPORT

Date of Inspection: August 22, 2018

By: Fernando Martinez, Professional Inspector #2945, Wendy Matson #3666, Elissa Martinez #10490

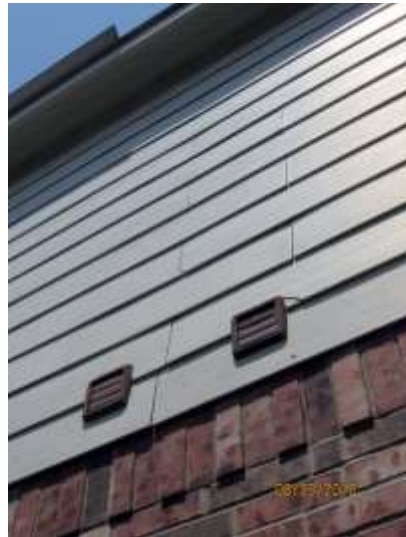
- i. The repair would be to remove all brick at this area in order to install a double lintel.
 - ii. Note that the lintel itself was installed properly (it is the excessive weight above it that is causing the problems)
2. Left elevation cement board siding has come apart at the joints. Re-nailing and caulk needed.

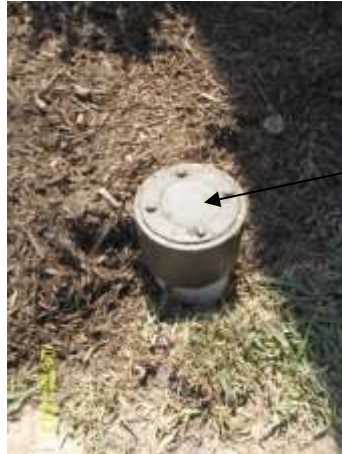
Pop up cover keeps the sewer from backing up into the home in this example photo
