INVASIVE STUCCO INSPECTION

Date: February 22, 2018 **Date of Inspection:** February 22, 2018

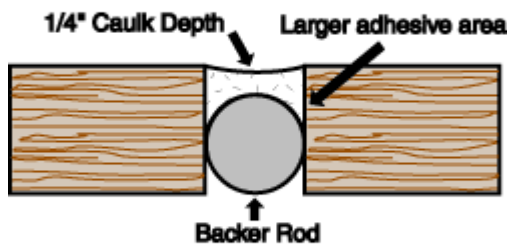
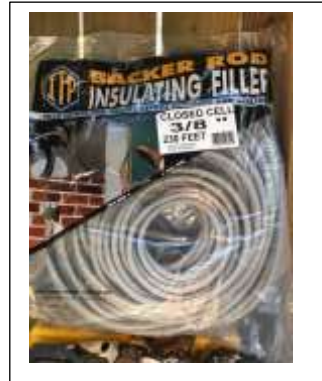
* **Backer rod method of water penetration between dissimilar materials, such as window and door frames calls for a 3/8" gap (1/2" for polystyrene) between the metal lath and the window or door frame, then the backer rod is inserted and caulked with a low modulus caulking such as NP1 urethane.**

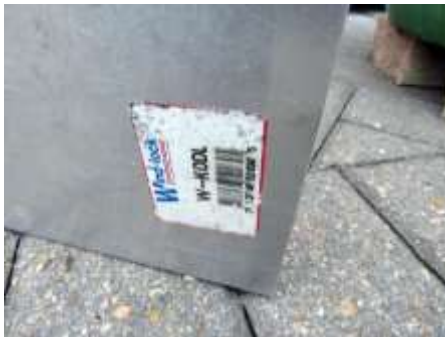
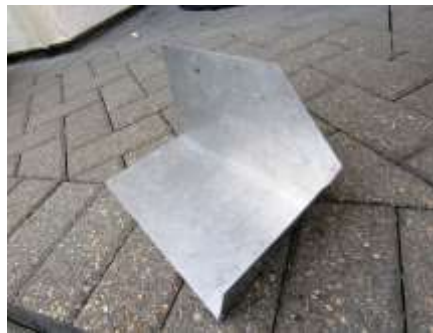
***Kickout Flashings – below is prefabricated aluminum type (vs job made)**

We recommend that Wind-Lock brand be used, shown at the end of this report. Stucco work should include “following the water trail” to assure that all deterioration is found, and source identified. Replacement of wall sheathing must be with plywood (not treated).

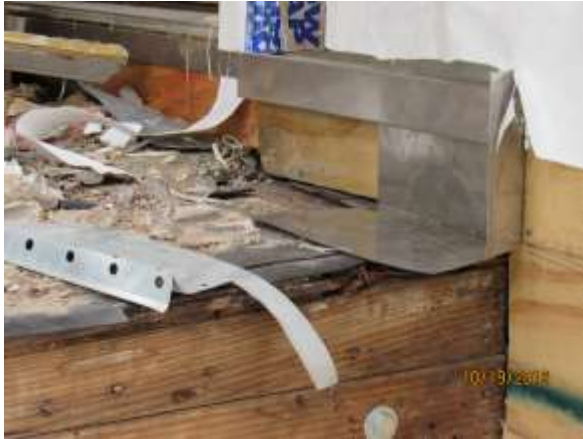
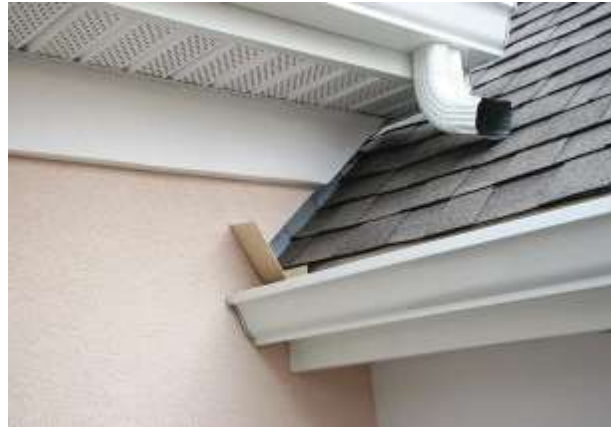
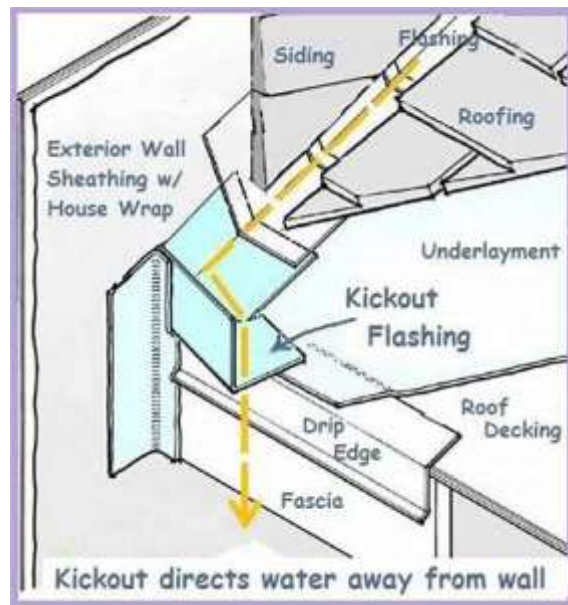
R903.2.1 Locations. Flashings shall be installed at wall and roof intersections, wherever there is a change in roof slope or direction and around roof openings. A flashing shall be installed to divert the water away from where the eave of a sloped roof intersects a vertical sidewall. Where flashing is of metal, the metal shall be corrosion resistant with a thickness of not less than 0.019 inch (0.5 mm) (No. 26 galvanized sheet).
