# Preferred Home Inspections, Inc.

## MOISTURE AND STUCCO REPORT

Date: February 13, 2012

Concerning: *6455 Bell Drive, Dallas, Texas*

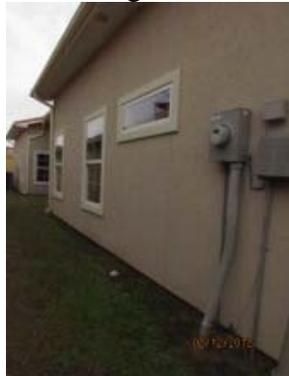
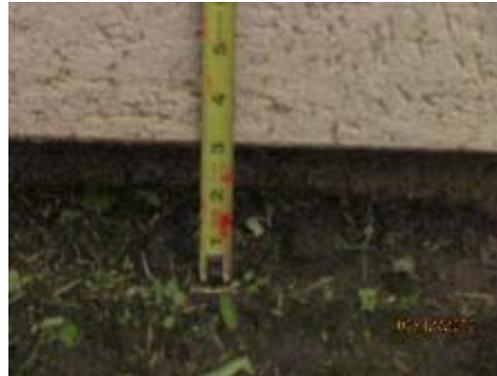
Due to the high grade between the home on the left side and high grade at the foundation of this home, wicking of moisture into the substrate and rusting of the weepscreed is inevitable. To obtain more distance between the stucco and grade, the inspector recommends regrading the existing area by removing 6" of soil, then reinstall sod. Regrading so that rainwater flows to the street is needed. \*IRC code ref Grading

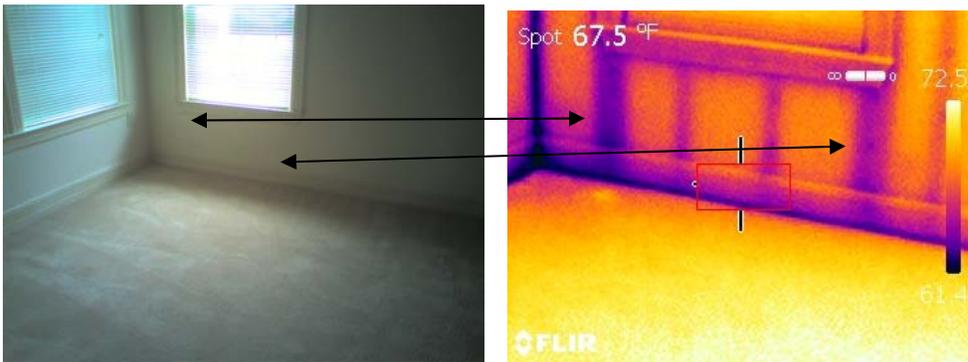
Above photo shows windows on left facing patio and window on right facing left elevation (note that entire window would not fit into same image)
